Electricity Distribution Service

Vector - Extreme event report

For the assessment period
1 April 2023 – 31 March 2024

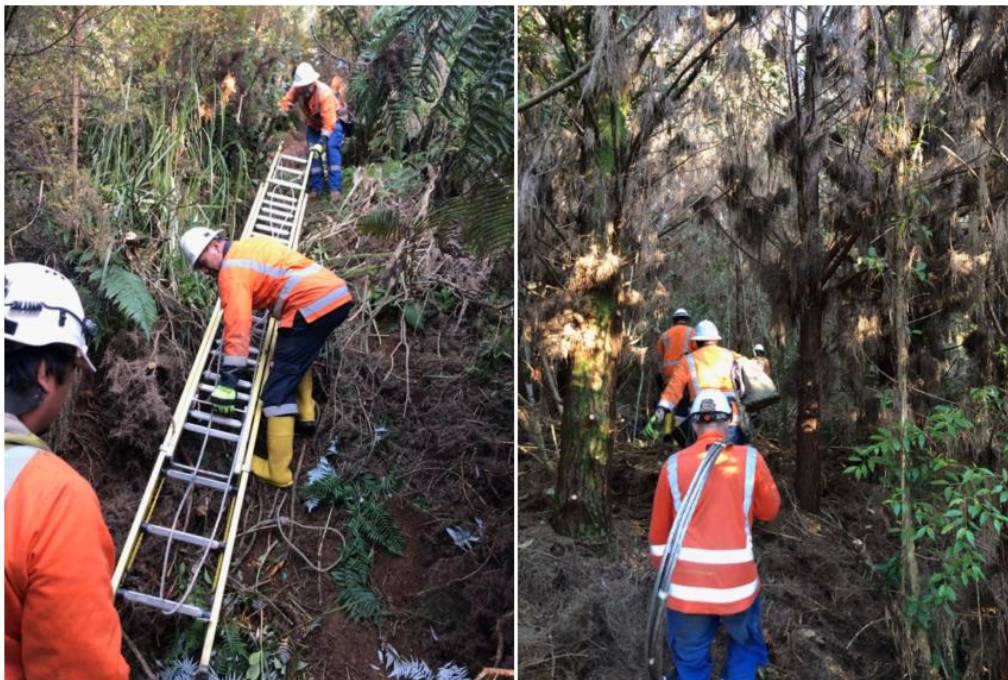
31. The location of the fault on circuit 59 was a key factor for the event exceeding the six million customer interruption minute threshold. The location of the fault caused six hours of effort to be expended finding the faulted section. Both ground and helicopter patrols were utilised. The location also caused considerable time to be spent with the restoration. Crews had to walk in equipment to the fault location from the nearest vehicle access point to affect the repair. The below images 1 and 2 are from the circuit 59 restoration on the day.
32. The time involved with locating and repairing circuit 59 meant that it could not provide n-1 supply for significant parts of the day – including to provide cover when circuit 58 experienced a second outage.

Image 1 and 2: field crews hiking equipment (ladders and conductor) to the fault location
