GRIDAWARE: KEY FINDINGS REPORT

Overview

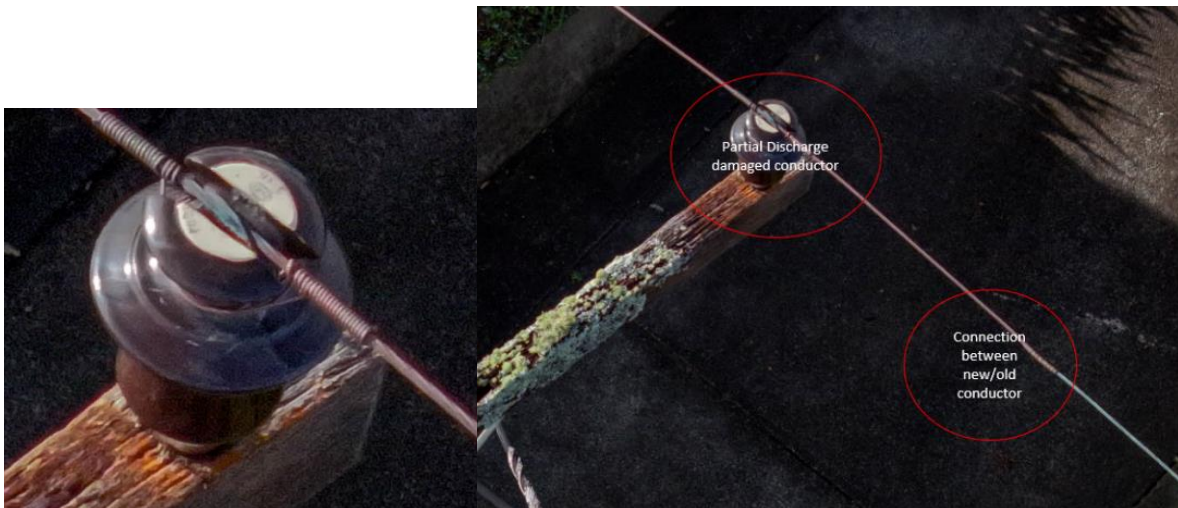
Overhead defect – unable to be seen from the ground

Reviewing the drone footage in conjunction with this acoustic information showed there was a partial discharge fault with this insulator causing aging to newly replaced conductor. It is the original insulator and was not replaced during a previous fault repair when the cable broke and fell. Originally the root cause was attributed to conductor but use of the new technology identified the actual cause and allowed for the correct remediation.

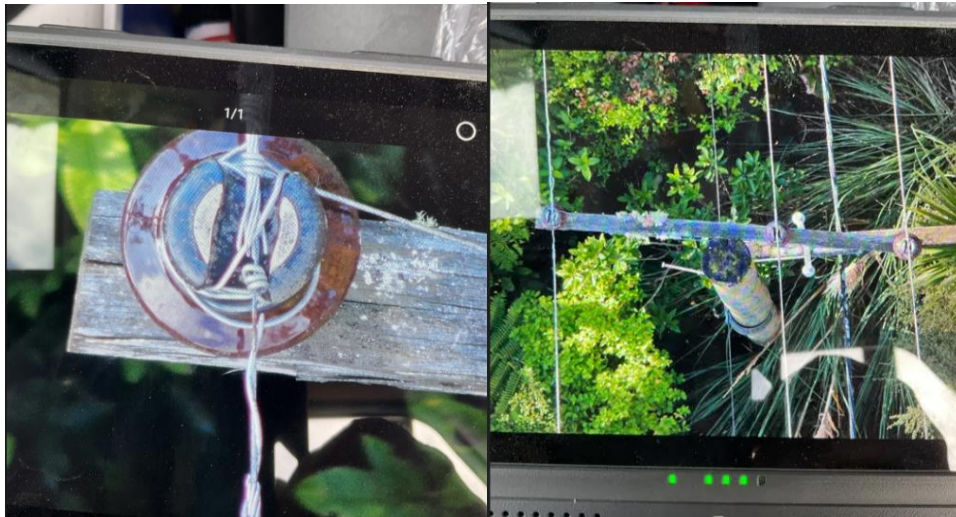
Overhead defect

During inspection of drone footage through GridAware one of our Inspectors identified a conductor that had functionally failed and was in danger of causing an outage. The location of this asset was in dense bush making identification all but impossible. The asset was repaired prior to failure in a planned and coordinated manner proving the new technology, process, and tools for inspections are working as planned.
